ASSESSMENT OF THE DISPOSITIONS OF MRCC-TÓRSHAVN WITH
RESPECT TO THE SAR OPERATION “JØKULFELL”

MINISTRY OF FISHERIES AND MARITIME AFFAIRS -
THE FAROE ISLANDS

15-JUNE-2005

REPORT NO. 2005-0750

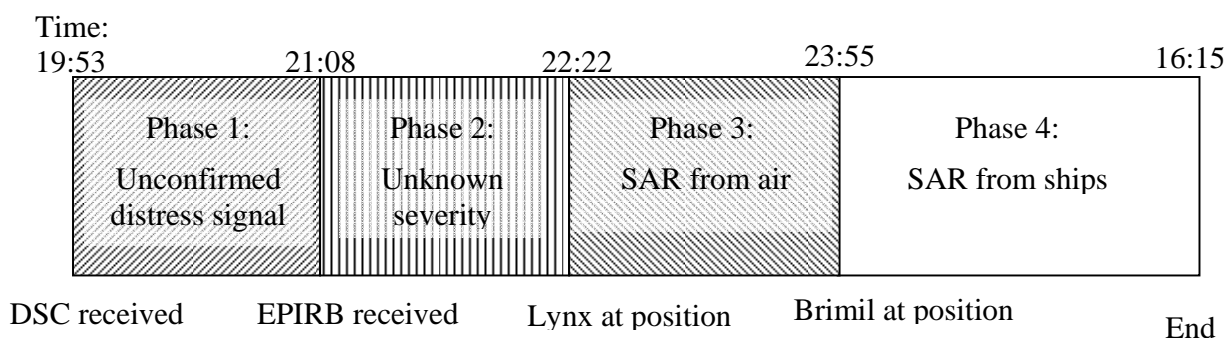
Figure 7: Outline of the main phases of the SAR operation

The whole scenario (outlined in more detail in Appendix 2) can be grouped into four phases (Figure 7). The first phase is characterised by the uncertainty related to the distress signal. Even though MRCC Tórshavn took the distress signal seriously, the scarce information about the situation imposed uncertainties to the decision making. The ship was unreachable on both radio and satellite telephone. When the EPIRB signal was received MRCC got a confirmation that the distress was real (phase 2). The severity of the situation was however not known. When the Danish navy Lynx helicopter arrived at the scene it was acknowledged that the situation was extremely severe (phase 3). For about one hour, the two helicopters were the only SAR resources at the scene. At about midnight three vessels arrived at the scene (Phase 4). The following day, an extensive search of the area was done both from ships, planes and helicopters.

This report is focusing on the two first phases since they are the most important when it comes to the dispositions and decisions made. Phase 4 is outside the scope of the project. Therefore, the STEP diagram covers the events until the Bell 412 helicopter arrives at the scene in phase 3.

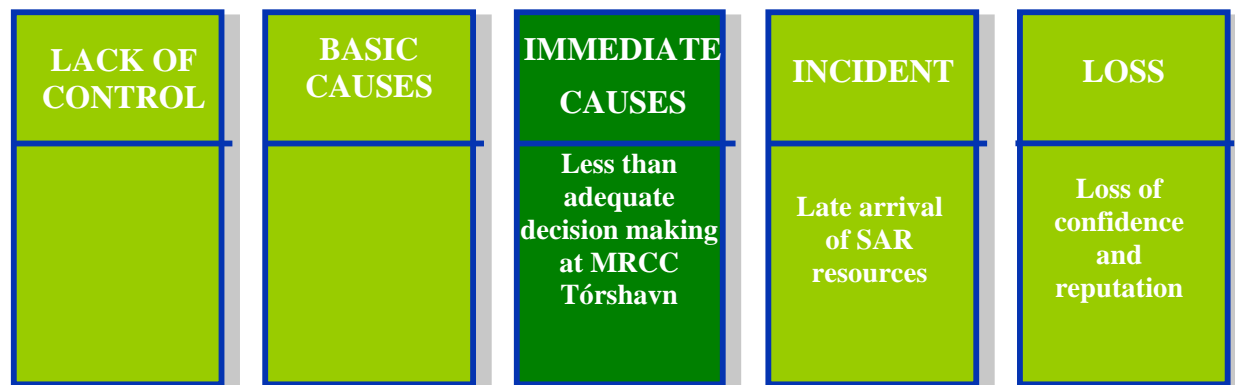
Figure 10: The LCM for Immediate Causes

The immediate causes can be identified by asking why the SAR resources arrived late at the distress position (Figure 10). The immediate causes are typically observable acts and conditions. The term immediate causes is used as they imply that there is another set of causes that are of a more latent and unobservable nature. These are called basic causes and they are assessed in the next chapter. The main immediate cause of the late arrival of SAR resources is related to the decision making at MRCC Tórshavn. Other immediate causes will be pinpointed in chapter 4.

The decisions of what resources to use and when to use them were based on three parameters: The information about of the distress situation, available resources for the SAR operation and considerations of the remaining SAR capacity at the Faeroe Islands. The information about the distress situation in phase 1 was as follows:

Looking at the basis for the decisions that was made regarding the dispositions, it can be concluded that the view on the four listed parameters influencing the decisions changed during the operation. During the first phase (figure 7), it was the lack of confirmation of the distress signal and the attributes of the frigate that influenced the decision. The leader of MRCC felt more information was needed before they could send all resources. It was decided to send Vædderen, because it is an advance SAR resource (see above).

When the message about the EPIRB was received it was considered as the confirmation they had been waiting for. The decision at this stage was to send the Lynx helicopter because it was closer, faster and can land on Vædderen if needed. It was also decided to send only one helicopter at this stage because of considerations regarding the remaining SAR capacity on the Faroe Islands. It was first after the Lynx helicopter had arrived on the scene that the seriousness of the situation was clarified. Based on this knowledge the Bell 412 was then sent.

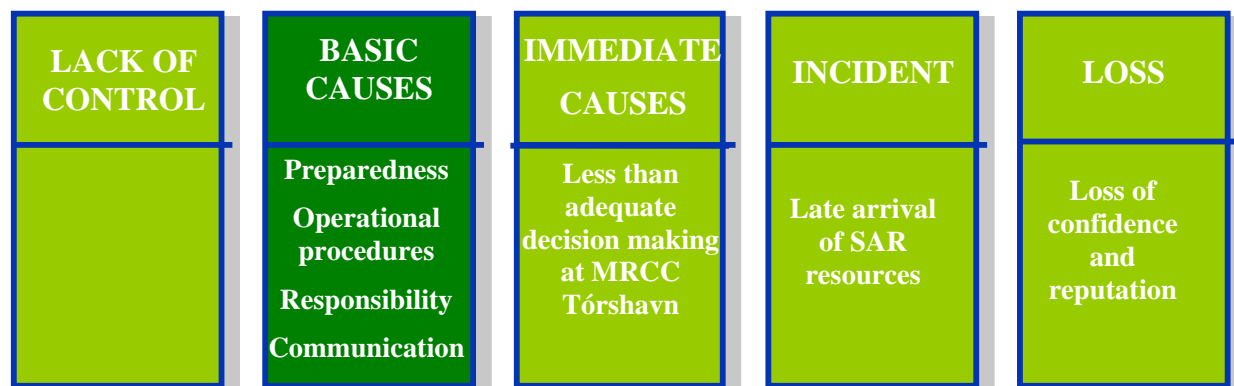
Figure 11: The LCM for Basic Causes

There were at least four basic causes that influenced the decision making at MRCC Tórshavn the evening 7th February. These are described in more detail and presented in Figure 11.

MRCC Tórshavn was taken over by the MFMA from the Danish Navy in 2002. After the takeover several important steps were taken to further develop MRCC Tórshavn, which today is recognised as a quality MRCC station. For example, it was conducted initial training of the

personnel constituting of some days hosting at foreign MRCC stations. However, their statistics shows that they have a relatively low intensity of incidents compared to stations like Norway's JRCC Sola and JRCC Bodø. As the frequency of incidents happening in MRCC Tórshavn's area is lower, this should require a higher training intensity in order to reach the same level of preparedness. The investigation revealed that there is a lack of training and drill experience in SAR operation and leadership at MRCC Tórshavn. Hence, MRCC Tórshavn had never experienced a DSC of the kind received 7th February 2005.

Under the start-up process in 2002 only the leader of the MRCC station was in a position to send SAR resources. When the station was up and running this procedure was not changed. Over time, however, the personnel got a closer relationship with the coastguard vessels Brimil and Tjaldrið as they also are organised under the MFMA. Consequently, a practice occurred that the personnel on duty sent the coastguard vessels themselves, even though they had to violate the procedures. The MFMA has an agreement with Atlantic Air (AA) to use the Bell 412 for 170 hours a year. However, the MRCC has not the same close relationship to AA and experience by using them. In sum both the procedures and the practice constituted an extra barrier for MRCC to send the Bell 412 compared to the coast guard vessels.

Another basic cause is the communication between different parties. Firstly, in the agreement between AA and MFMA it is stated that the helicopter is to be ready in one hour. The logs and interviews reveal however that there is confusion about what the term "ready" implies. AA responded that the helicopter was "ready" 20:17. At that time the Bell 412 was not fully manned, not fully bunkered and still located inside the hangar. This was a source of confusion for MRCC Tórshavn. The communication weaknesses between AA and MRCC Tórshavn and AA's actions during the situation raise a reason to question the alertness of the Bell 412.

A fourth area of less than adequate communication can be seen in the notification of the Danish frigate Vædderen. In this communication several aspects failed. This advanced SAR resource seems to have missed the “Mayday Relay“ message sent from Tórshavn Radio 20:18 on medium frequency 2148kHz. Vædderen was first aware of the situation at 20:30. Given its position and sailing speed, this advanced SAR resource should have been asked to go to the distress position at the same time as Brimil was alerted 19:57. There was also a communication weakness regarding the orders of when to send and prepare the Lynx. This is discussed in more detail in chapter 3.5.4.

A fourth area of unclear responsibility and communication was between MRCC Tórshavn and the naval frigate Vædderen. In principle the frigate could on its own initiative have sailed towards the distress position and contact MRCC Tórshavn at an earlier stage. The decision to send the Lynx could both be taken by the commanding naval personnel and by MRCC Tórshavn. In the given scenario the personnel onboard Vædderen had more experience with the use of helicopters in such situations compared to MRCC Tórshavn, and also had the power to send the helicopter independently of MRCC’s requests. The dual responsibility roles and the bias in experience may both have affected the fact that Vædderen did not instantly sail towards the distress position and the fact that the Lynx was not sent before the EPIRB signal was received.

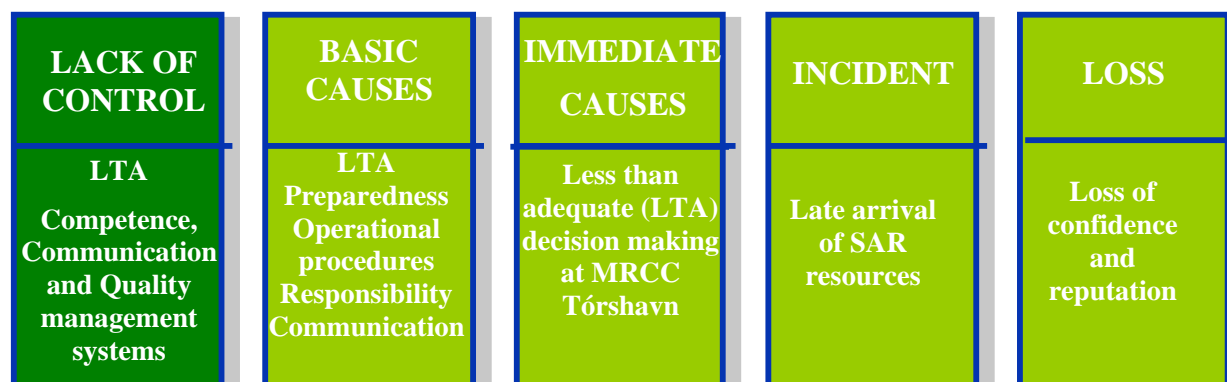
Figure 12: The LCM for Lack of Control

The LCM indicates that behind a basic cause there is a missing standard, an inadequate procedure or lacking compliance to the procedures. Most of the identified basic causes could have been identified and controlled in advance, if MFMA had implemented systems to assure a high quality of MRCC Tórshavn. There exists no formal system that assures that the competence of the MRCC personnel is adequate. There are neither implemented systems to assure adequate communication, nor systems that maintain clear levels of responsibility. Further, there exists no overall quality assurance system for MRCC Tórshavn (Figure 12).

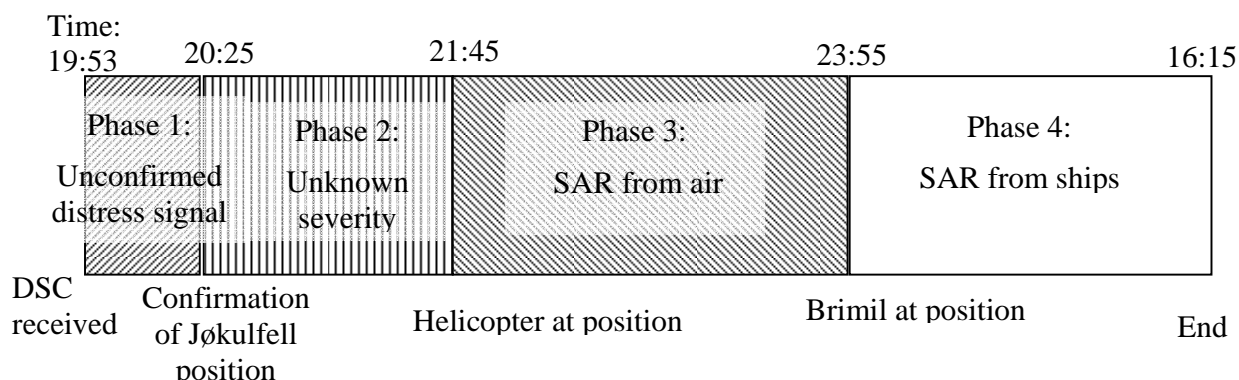
Figure 13: Outline of the main phases of a potential SAR operation based on an earlier decision

If the Bell 412 had been given a “go” 20:25 it is likely that it still would have needed roughly 35 minutes before being airborne. The estimate of 35 minutes is based on the fact that they were told to be relaxed and check the weather, instead of being given a clear order which is the case in the ideal scenario. This means that in this analysis, the Bell 412 would be airborne 21:00 and on the scene 21:45.

Alternatively the Lynx would be airborne 21:10 and arriving at the scene approximately around 21:45. In both cases the decision would have resulted in at least one helicopter at the distress position at 21:45, approximately 40 minutes earlier than what was experienced on the 7th February (see Figure 13).

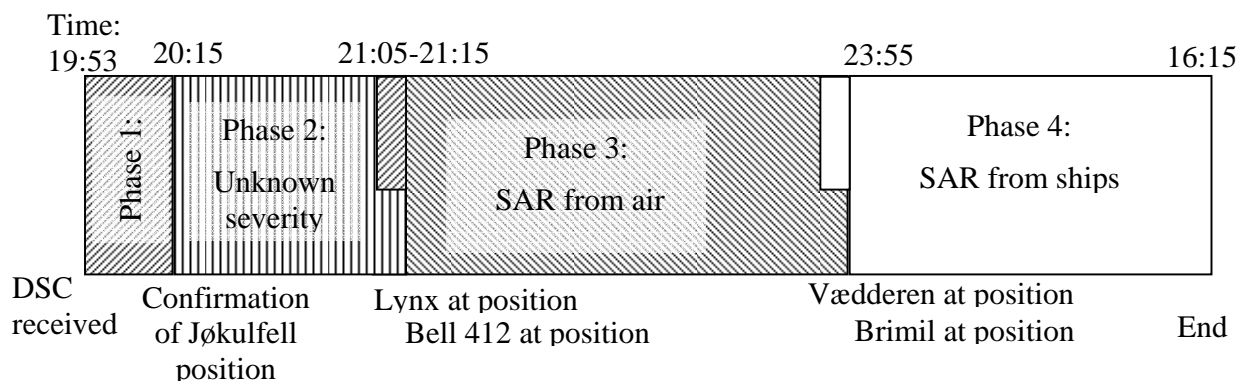
Figure 14: Outline of the main phases of an ideal SAR operation.

The other alternative potential scenarios outline the effects of an ideal use of the given SAR resources. The term “ideal” is not used in the sense that it is unachievable, but rather that all decisions and operations are carried through as smoothly as reasonable practicable (Appendix 3a). It can not always be expected that the Danish Frigate is in such a favourable position as it was on the 7th of February. Therefore an ideal SAR operation with the use of the Bell 412 is also outlined (Appendix 3b).

In an ideal scenario it is assessed that it should be possible to get the confirmation that Jøkulfell was on its route in the area of the distress position at around 20:15 (at the latest) and that either one or both of the helicopters would be given a “go” at that time. In these cases the Lynx would be airborne approximately 20:35 and the Bell 412 would be airborne 20:30. The Lynx would be at the distress position approximately 21:05 and the Bell 412 at the distress position 21:15 (Figure 14).
